FIVE STAR INSPECTION SERVICES, LLC

Re 6 Pine Drive
Shoreline, CT -6400

SUMMARY

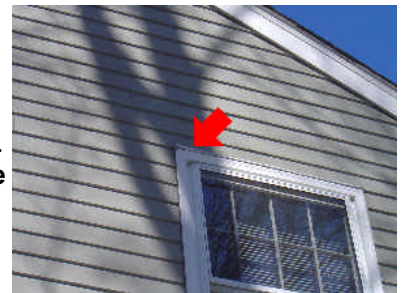
MATERIAL: Wood.
CONDITION: MAINTENANCE: The drip cap over several of the windows on the south side of the house is damaged loose and/or deteriorated, which can allow moisture to get beneath the trim and possibly result in deterioration of the sheathing. **I recommend replacing or securing all of the loose/deteriorated areas and assuring that all seams are caulked and painted fully.**

Loose or deteriorated drip cap (south side windows). REPAIR OR REPLACE.

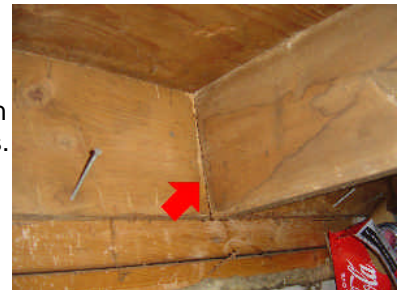
MATERIAL: Metal, Glass, storm door.
CONDITION: MAINTENANCE: One or more of the joist supporting the landing to the entry door from the garage to the family room is loose and has pulled away from the header. This can result in an unsafe condition if further movement occurs. **I recommend a carpenter properly secure the joist.**

Garage entry door landing joist loose. SECURE.

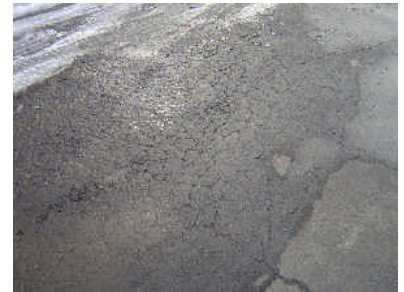
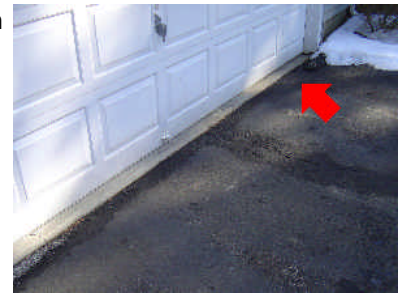
MAINTENANCE: There are cracks and erosion to the driveway due to long term exposure to water. This can or has resulted in heaving and further deterioration of the surface. **I recommend a driveway contractor evaluate the driveway and provide you with a repair plan.**

MAINTENANCE: The driveway slopes toward the garage, which increases the potential for water entry and/or creating standing water during heavy rains. This has resulted in rot to the bottom of the studs. **I recommend re-grading these areas to insure that water drains 6 to 10 ft. away from the foundation at a slope of 6" per 10 ft. and to consider installing a sub-surface drain.**

Cracks and erosion noted to driveway. REPAIR.

Driveway pitched to garage. RE-GRADE AND/OR INSTALL DRAIN.

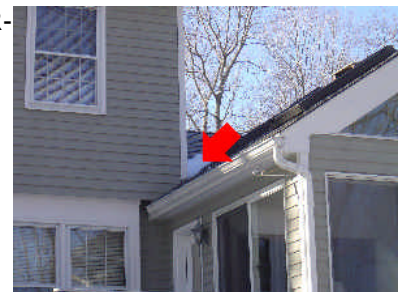
TYPE: Asphalt.
LOCATION: Sidewall, Valley, Ridge, Eave, Rake, Vents, Skylight.
CONDITION: Valley terminates at sidewall. SEE "INTERIOR-WALLS" FOR RECOMMENDATION.

Valley terminates at sidewall. SEE "INTERIOR-WALLS" FOR RECOMMENDATION.

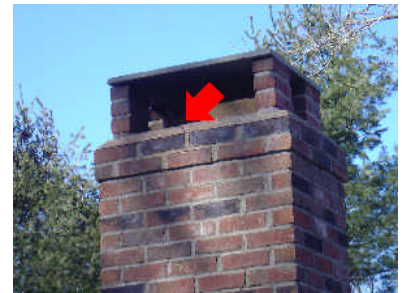
CONDITION: MAINTENANCE: There is a crack in the chimney crown. This can allow water to deteriorate the crown, bricks and mortar. **I recommend a chimney contractor or mason repair the crown as needed.**

Cracked chimney crown. REPAIR.

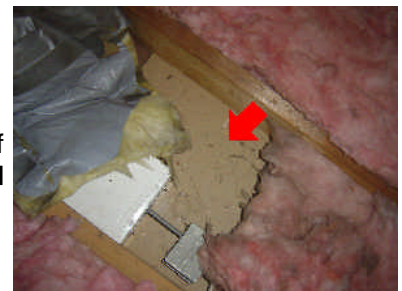
CONDITION: MAINTENANCE: There are gaps in the insulation around light fixtures and/or in other areas where previous work has been performed. This allows heat to escape to the attic in the winter and increase the possibility of ice damming and condensation. **I recommend insulating these sections.**

Gaps in the attic insulation. INSTALL.

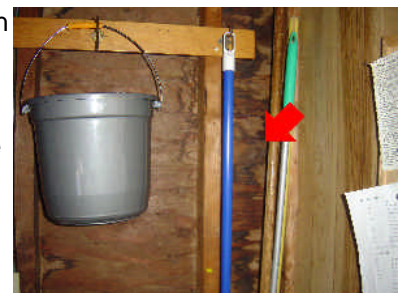
MAINTENANCE: There is rot to the bottom of the studs adjacent to the garage door due to long term exposure to moisture. This can lead to weakness and movement of the studs. **I recommend replacing all rotted areas and insuring the driveway slopes away from the garage door and the gutter leaders route water away from the area.**

Rot at bottom of studs (next to garage door). REPAIR.

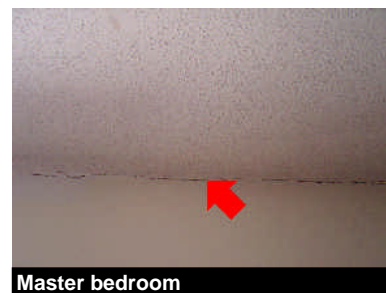
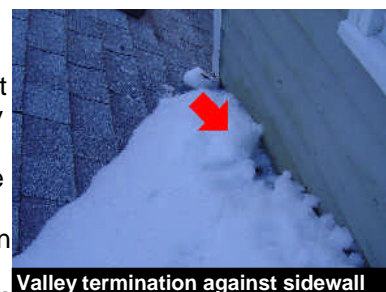
IMMEDIATE REPAIR: There are water stains and loose tape in the family room where the sidewall meets the ceiling. Although I could not determine the point of entry of the water, it may be related to the roof valley that terminates against the sidewall. The presence of moisture will accelerate the deterioration of sheetrock and wood that could lead to a loss of strength in this area. **I recommend a roofing contractor fully evaluate the flashing, roof covering and decking in this area and make repairs as warranted.**

MAINTENANCE: There are water stains and loose tape in the master bedroom where the sidewall meets the ceiling and in the ridge of the sun room. These areas appeared dry at the time of the inspection. The master bedroom stains may be the result of wind drive rain entering the gable end vent and/or typical aging of the structure. Stains were noted on the plywood sheathing and top plate. The sun room stains may be related to the prior roof covering. **I recommend repairing this area with a non shrinking compound, plaster filler or caulking and then monitor further as the structure ages.**

Moisture stains and/or damage viewed. EVALUATE FLASHING.

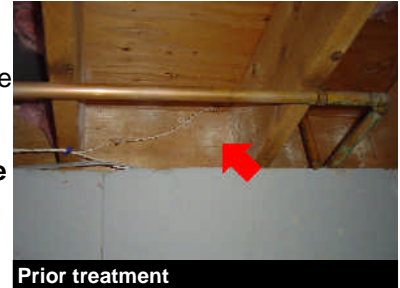
TYPE: Wood.
CONDITION: MAINTENANCE: There is evidence of prior treatment for carpenter ants. Although no damage was observed in visible areas, damage could be present in areas not fully visible for inspection. **I recommend you obtain treatment documentation and to monitor the area for future insect activity.**

Prior treatment for carpenter ants noted. ASK OWNER.

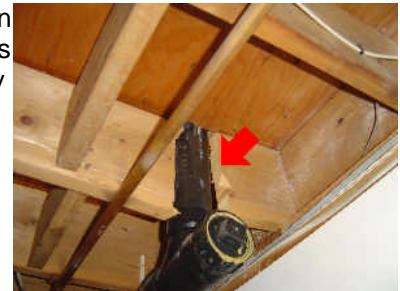
TYPE: Wood.
CROSS BRACING: Wood solid bracing.
CONDITION: MAINTENANCE: One of the floor joist has been cut to provide a path for the drain line. This has substantially reduced its load bearing capability and may result/have resulted in sagging. **I recommend reinforcing or replacing this joist to restore it to its original design strength.**

Joist is cut and sagging. REPLACE OR INSTALL SUPPORT.

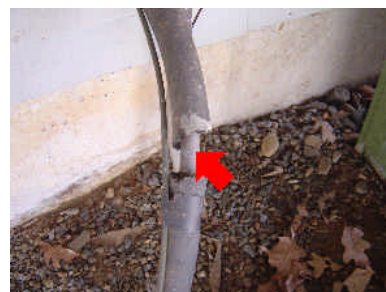
MAINTENANCE: Sections of insulation on the coolant line are missing and/or deteriorated, which decreases the efficiency. **I recommend this line be fully insulated.**

Missing insulation on A/C coolant line. INSULATE.

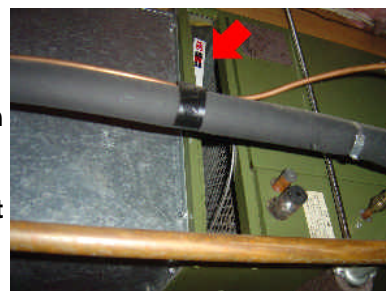
MAINTENANCE: The air filter is incorrectly sized, not properly supported and/or the cover is not installed, which allows unfiltered air to circulate through the system. **I recommend an HVAC contractor service and clean the air handler, re-route the coolant line (so the correctly sized filter can be installed without being bent), install a correctly sized filter and replace the filter housing cover.**

MAINTENANCE: Forced air distribution systems are designed to deliver conditioned air throughout the home. These systems need to be maintained as it relates to indoor air quality and the presence of potential contaminants such as dust, animal hair, mold, other allergens, etc. No testing was done to determine the presence, amount or type of any contaminants. Although the necessity for cleaning varies considerably depending on the conditions within the home and system utilization, cleaning is generally recommended every 4-6 years. **I recommend an HVAC contractor or duct cleaning professional assess and clean the duct system if needed and to routinely clean the ducts as part of your regular environmental hygiene program.**

A/C filter housing cover missing & opening obstructed. REPLACE & RELOCATE COOLANT LINE.

A/C filter may be incorrectly sized. REPLACE.
