FIVE STAR INSPECTION SERVICES, LLC

Re 6 Pine Drive
Shoreline, CT -6400

SUMMARY

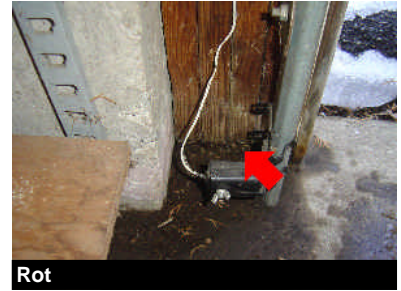
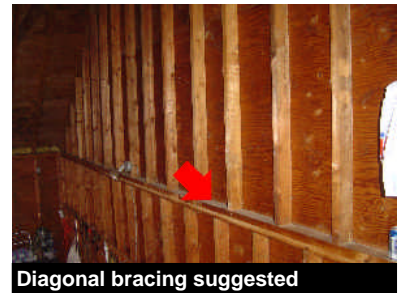
Wood.

Functional.

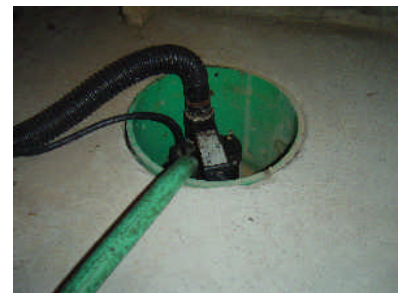
TYPE: Pit. Electric. Pump. Uncovered.

CONDITION: Functional.
NOTE: See "Maintenance Tips" handout for suggested improvements.

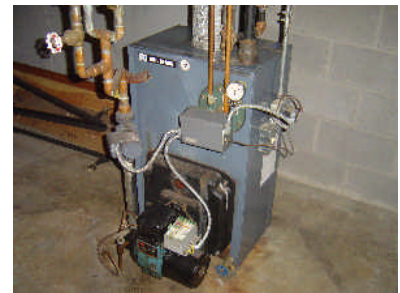
SYSTEM TYPE: Forced hot water boiler, Brand = Weil McLain, BTU = 131,000.

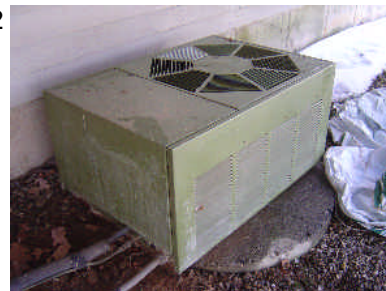
Energy source = Electric, Brand = Rheem 2-1/2 Ton 4/83.

Outside air temperature was below 65 degrees and was unable to test system at this time.

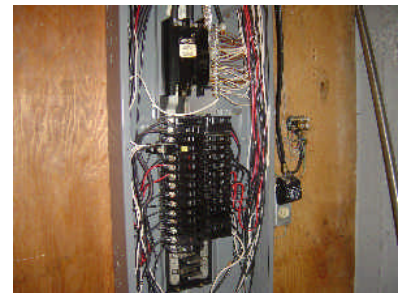
PANELS:
MAIN TYPE: Circuit breakers, Amps = 200.

DISCONNECT LOCATION: Basement.
MAIN LOCATION: Basement.
MAIN CONDITION: Functional.
